# GEAR FAILURES

- *how to recognize them*
  - *what causes them*
    - *how to avoid them*

Reprinted from MACHINE DESIGN December 7, 1967  
Copyright 1967 by The Penton Publishing Co., Cleveland, Ohio 44113

## EUGENE E. SHIPLEY

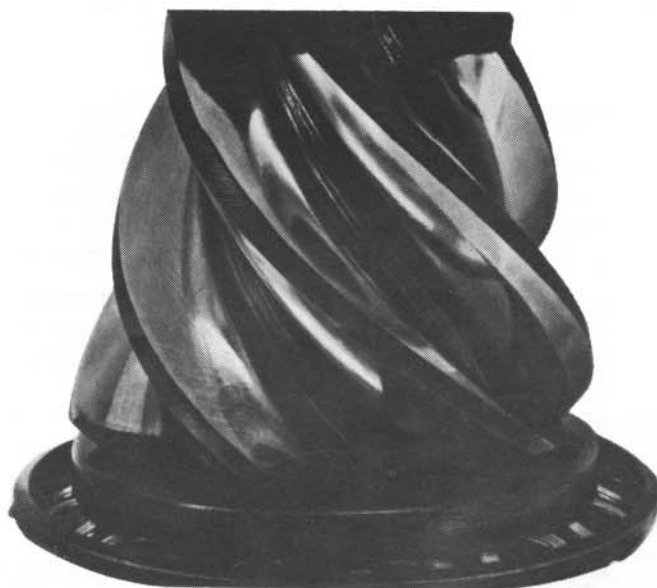
Polishing is a very slow wearing-in process in which the asperities of the contacting surfaces are gradually worn off until a very fine, smooth surface develops.

**Cause:** This condition is usually caused by metal-to-metal contact during operation. Generally, “polishing-in” occurs on slow-speed applications where the elasto-hydrodynamic lubrication film is not sufficiently thick and the gears are operating near the boundary-lubrication regime.

**Polishing:** Run-in under operating conditions, this hardened hypoid pinion has developed a highly polished surface. Undoubtedly the extreme-pressure additives in the lubricant had a tendency to promote polishing on the tooth surfaces.

**Remedy:** Often this condition need not be avoided unless the design life of the equipment is much longer than the predicted wear life based on polishing-in. Polishing gives good conformity of the surfaces.

After the gear is well polished-in, the surface can be protected by substituting a lubricant with a higher viscosity, by reducing the transmitted load substantially, or, in some cases, by increasing the operating speed to obtain a better elasto-hydrodynamic oil film.

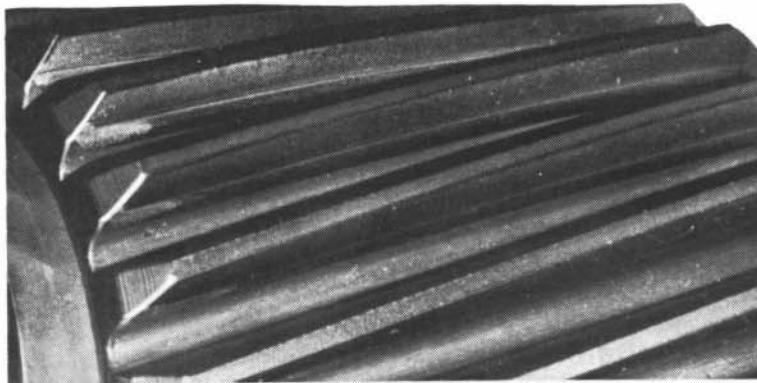
The type of wear classified as moderate takes place over a relatively long period of time. The contact pattern indicates that metal has been removed in the addendum and dedendum area; also, the pitch line begins to show as an unbroken line.

**Cause:** Moderate wear is most commonly caused by an inadequate lubrication film, with the film

**Moderate Wear:** The addendum and dedendum sections of these medium-hard gear teeth have worn, causing the operating pitch line to become visible because little if any material has been removed along this line.

thickness being too thin for the load. Dirt in the lubrication system can also cause this type of wear.

**Remedy:** One solution is to specify a lubricant with a greater film strength, or one with a higher viscosity. Also, the unit can be operated at a greater speed to build up the lubricating film. Finally, a gear material with a higher wear resistance can be specified.

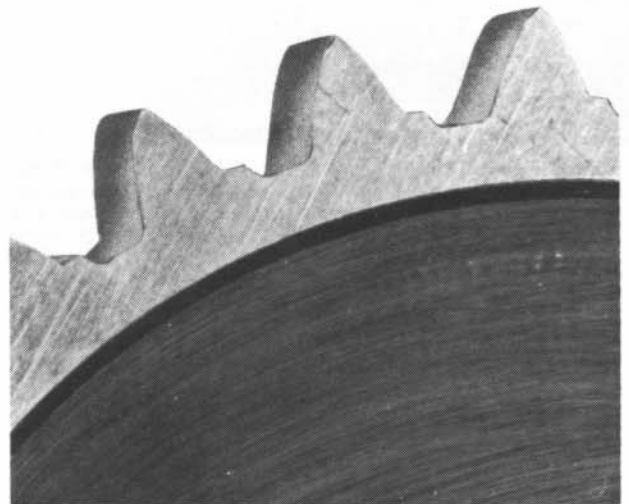
This is simply normal wear which has progressed to the point where a considerable amount of material has been removed from the surfaces. The pitch line is very prominent and may show signs of pitting.

**Cause:** This problem is usually caused by the failure to notice early enough that wear is in prog-

**Excessive Wear:** Material has been uniformly worn away from the tooth surface causing a deep step. The tooth thickness has been decreased and the involute profile destroyed. Some slow-speed gears can operate on such a profile until so much material has been worn away that the tooth fails under beam bending fatigue.

ress. When enough material has been worn from the tooth surface, the involute profiles are destroyed and the gears begin to run roughly. The situation is aggravated by the rough running, causing still

greater wear. Eventually the surface is such that the gears are no longer fit for reliable service.

**Remedy:** This condition could be avoided by using the same methods given for moderate wear—increasing lubricant film strength or viscosity, or increasing pitch-line velocity.

If the gear unit is splash-fed, changing to a positive spray lubrication system with a filter will help keep wear particles out of the gear mesh and ensure that adequate lubricating oil is delivered to the working surfaces.

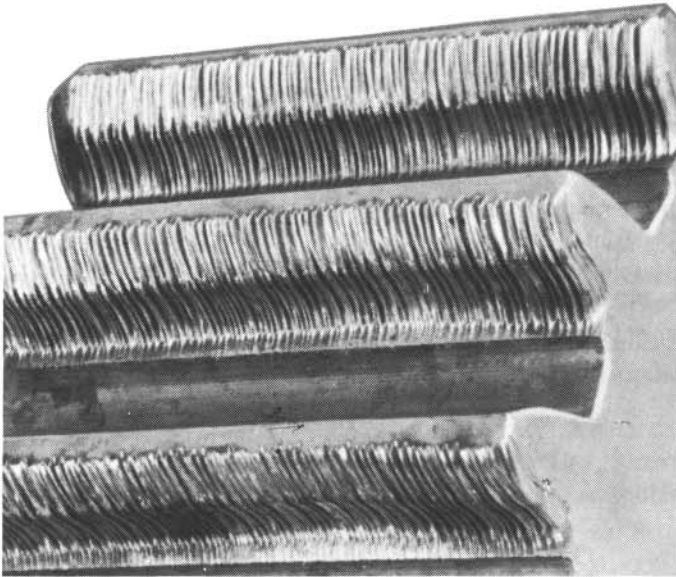
When abrasive wear has taken place, contacting surfaces show signs of a lapped finish, radial scratch marks or grooves, or some other unmistakable indication that contact has taken place.

**Cause:** Foreign material in the lubrication system ordinarily causes abrasive wear. The particles may

**Abrasive Wear:** In this extreme case, a large portion of the tooth of the bronze pinion has worn away due to an accumulation of abrasive particles in the lubricant. Note the deep ridges, and the ends of the gear teeth, which were not subjected to the abrasive action.

be metallic debris from the gear and bearing system, weld spatter, scale, rust, sand, etc. Abrasive wear is often noted soon after startup of a new installation, before the filter has had a chance to clean the system.

**Remedy:** This type of wear can be remedied by the use of a filter or, where a filter is already being used, a finer grade of filter. Alternatively, a higher-viscosity lubricant will develop a thicker oil film, which will pass fine particles without scratching. Of course, the best way to guard against early abrasive wear is to see that the gearbox and lubricating system are carefully cleaned before use.

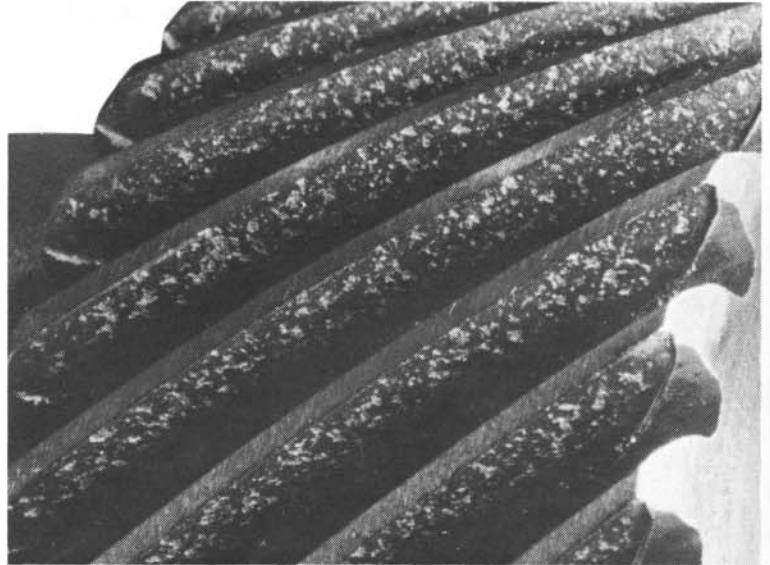
This is a deterioration of the surface due to chemical action. It is often caused by active ingredients in the lubricating oil, such as acid, moisture, and extreme-pressure additives.

**Cause:** The oil breaks down so that corrosive chemicals present in the oil attack contacting surfaces. Often this action affects the grain boundaries, causing fine pitting more or less uniformly over the tooth surfaces. At high temperatures, extreme-

**Corrosive Wear:** Although considerable wear has taken place, the surface still shows signs of having been attacked chemically. Wear of this nature will continue until the gear surface is beyond usefulness.

pressure additives sometimes form very active corrosive agents. Lubricants can also become contaminated from absorption of foreign material from external sources.

**Remedy:** Because they are chemically active, lubricants with high anti-scoring, anti-wear additive content must be kept under careful observation to ensure that they are not attacking working surfaces. By checking the lube oil for breakdown and by changing the lube oil at regular intervals, corrosive wear can be avoided.

At times, gear-tooth surfaces can be affected chemically during processing in the factory—for example, when copper plate is stripped from the gear after carburizing or when nital-etch is used to detect grinding burns. To avoid trouble of this nature, proper processing procedures must be set up and carefully followed.

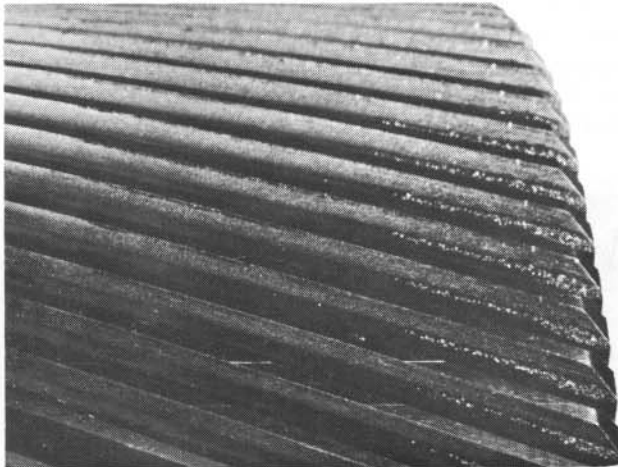
This condition is characterized by small pits from 1/64 to 1/32-in. in diameter. Initial pitting occurs in localized, over-stressed areas; it tends to redistribute the load by progressively removing high contact spots. Generally, when the load has been redistributed, the pitting stops and the contact surfaces smooth over.

**Cause:** Initial pitting is usually caused by gear-tooth surfaces not properly conforming with each other or not fitting together properly. This can

**Initial Pitting:** Pitting began on the outside end of the helix because of a small amount of misalignment, with pits of small diameter. The pitting worked its way from the end to the middle of the tooth. Eventually pitting stopped and the pitted surface began to burnish over, indicating that the load across the tooth had become more evenly distributed. This type of pitting, often called corrective pitting, is most common in medium hard gears.

be a result of minor involute errors or local surface irregularities, but most often it occurs because there is not proper alignment across the full face width of the gear mesh.

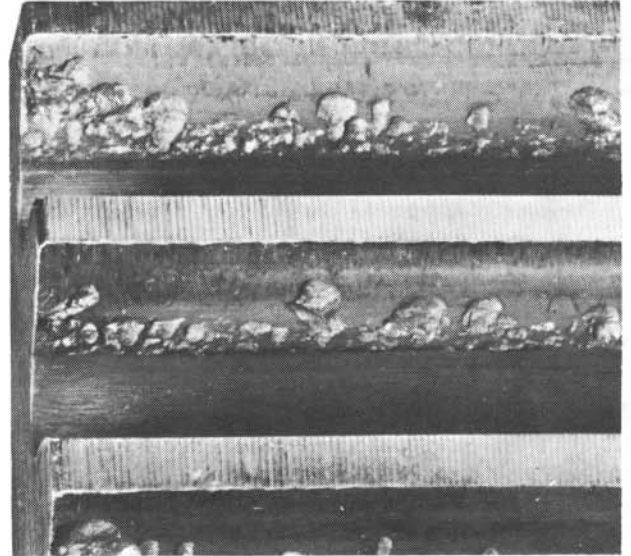
The dedendum section of the drive gear is often the first to experience serious pitting damage; however, as operation continues, pitting usually progresses to the point where a considerable por-

**Cause:** Destructive pitting usually results from surface overload which cannot be alleviated by corrective (initial) pitting. Once enough stress cycles have been built up, pitting continues until the tooth profile is completely destroyed, causing extremely rough operation and considerable noise. Often a bending fatigue crack will originate from

**Destructive Pitting:** Heavy pitting has taken place, predominantly in the dedendum region. The pitted craters are larger than those in initial pitting. Some pitting has also taken place in the addendum region.

a pit, causing a premature tooth breakage failure.

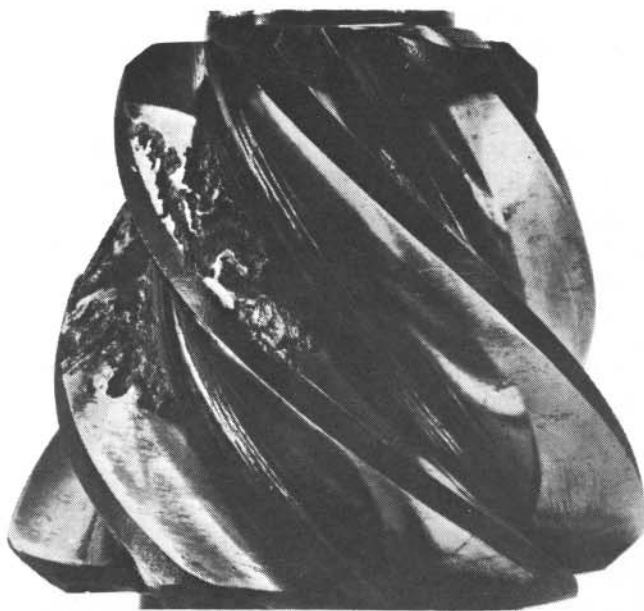
Spalling is similar to destructive pitting except that the pits are usually larger in diameter and quite shallow. Often the spalled area does not have a uniform diameter.

**Cause:** Spalling is usually caused by excessively high contact stresses. Usually, large pits are formed; because stress levels are high, the edges of the

**Spalling:** This hardened pinion shows an advanced stage of tooth spalling. Material has progressively fatigued away from the surface until a large irregular patch has been removed.

initial pits break away rapidly and large irregular voids are formed. Often these voids join together.

**Remedy:** Contact stress on the gear surface can be reduced below the endurance limit of the material. If the gear material is not hardened, hardening will give the material increased surface strength. Often a complete redesign of the gear elements is best since destructive pitting and spalling are evidence that the gears do not have sufficient surface capacity.

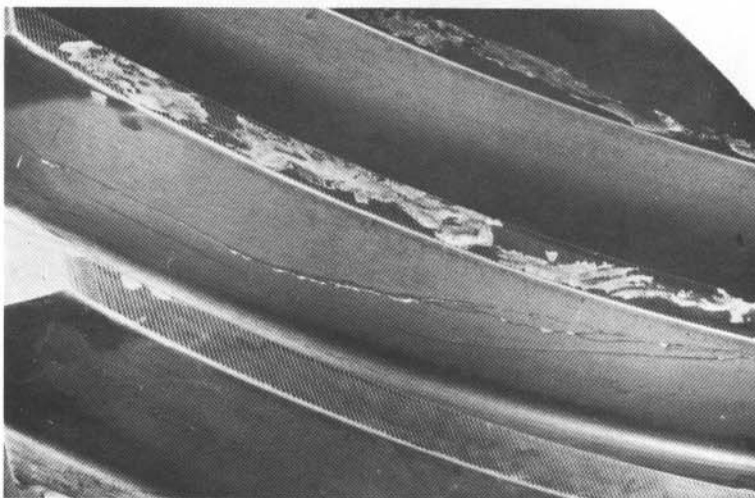
Although not considered a pitting failure, case crushing may appear similar in that damage has occurred on the contacting surface. It occurs in heavily loaded case-hardened gears, such as those which are case-carburized or nitrided.

Failure often occurs on only one or two teeth of a pinion or gear; the other teeth appear to be undamaged. Often, longitudinal cracks appear on

**Cause:** Cracks originate at the subsurface when stresses exceed the strength of the subsurface material. The cracks propagate along the case-to-core boundary and to the surface of the gear tooth. When several cracks reach the tooth surface, large chunks of material are removed. Failures are caused by insufficient case depth or by very high residual stresses in the gear.

**Case Crushing:** Several large longitudinal cracks, and several smaller ones, have appeared in the contact surface of this case-carburized bevel gear. The major cracks originated deep in the case-core structure and worked their way to the surface. Long chunks of material are about to break loose from the surface. The cracks should not be confused with normal fatigue cracks, which result from high root stresses and normally form below the contacting face.

**Remedy:** Failures most often can be overcome by increasing the effective depth of the case material. A change in basic material can be considered—for example, one that produces a hard core material for the same depth of case. Some carburizing materials will produce a 40-Rc core whereas others will only produce 30-32 Rc. This amounts to a considerable difference in strength.

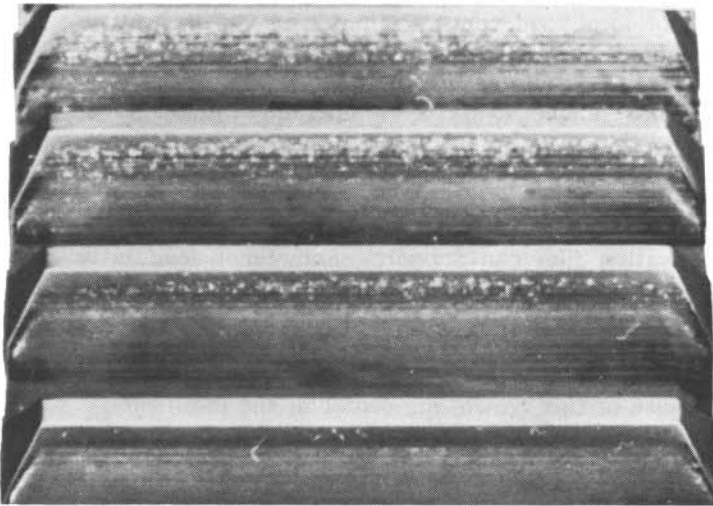
Frosting occurs in the early stages of scoring. Usually the dedendum section of the driving gear is the first to show signs of surface distress, although frosting can first show up on the addendum section.

**Cause:** Frosting is caused by heat in the mesh, which results in only marginal lubrication. The heat of the mesh and the bulk temperature of the rotating gears combine to break down the lubrication film.

**Frosting:** This hardened and ground spur gear shows the early stages of frosting. In this case the addendum portion of the teeth shows the spotty frosting pattern. Damage to this gear is negligible at this stage.

**Remedy:** A very careful break-in cycle is often beneficial. A break-in cycle starting with reduced

speeds and reduced load will condition the gear-tooth surfaces and improve the conformity of the contacting surfaces so that less local heat will be generated because of better load distribution. Reduced oil temperatures or better control of temperature fluctuations will tend to keep the heat level within safe limits. A mild extreme-pressure oil may be helpful but may not be necessary.

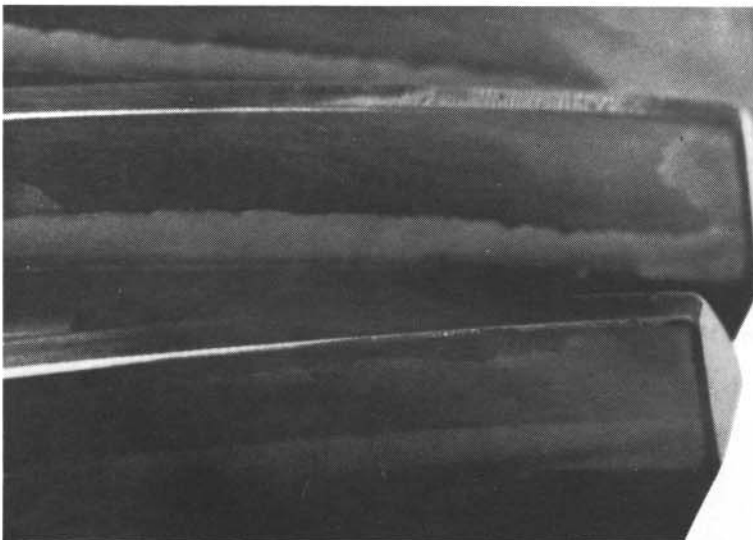
**Frosting:** This hardened helical gear shows a typical frosting pattern. Note that frosting is predominantly in the dedendum section, although patches do appear in the addendum section. This frosting pattern shows no radial welding and tear marks.

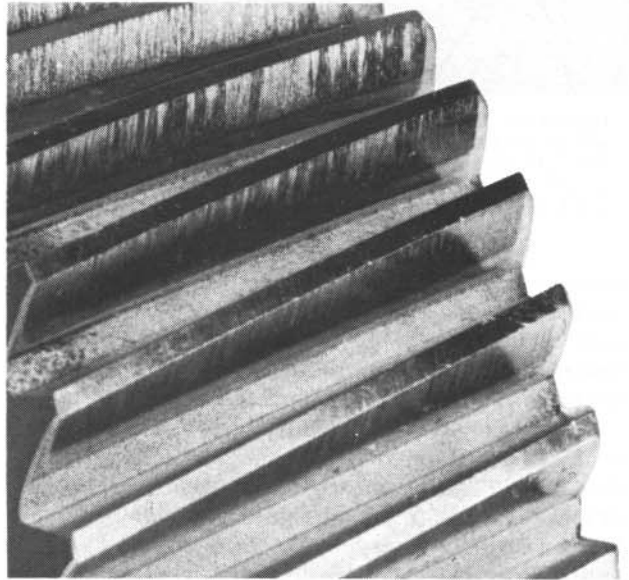
In this type of failure, a characteristic wear pattern shows up on the addendum or dedendum (or both) of the gear teeth, often in patches. At times,

there are indications of radial tear marks; however, this is not always the case. Generally, hard gears appear more frosted. Softer gears show some frosted appearance along with fine radial tear marks.

**Cause:** Excessive heat in the gear mesh causes this condition, causing lubricant breakdown.

**Light to Moderate Scoring:** At this stage, scoring has a frosty appearance. On close examination, it can be seen that there has been metal-to-metal contact, and alternating welding and tearing.

**Remedy:** The obvious remedy is to reduce the amount of heat in the mesh by cutting down on

the load being transmitted or the speed of the rotors, or by reducing the inlet oil temperature, which in effect reduces the bulk temperature of the gear rotors. A lubricant with extreme-pressure additives can be substituted. In some cases, a solid lubricant plated on the contact surface helps prevent the scoring from progressing. Also, honing has found increasing use in guarding against scoring.

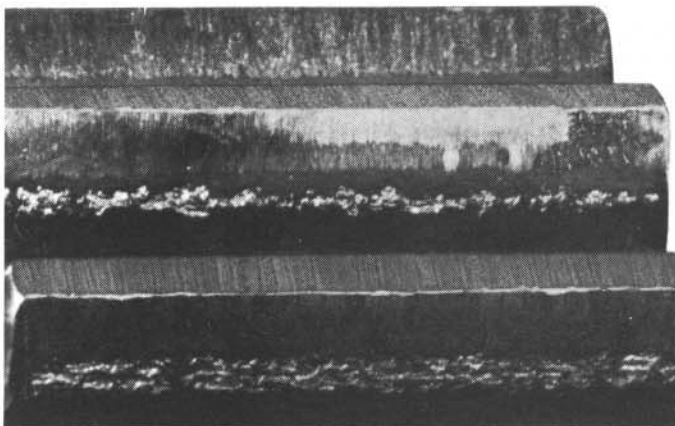
This type of failure shows definite indications of radial scratch and tear marks in the direction of sliding. Often material has been displaced radially over the tips of the gears. Also, there are indications that considerable material has been removed from above and below the pitch line, and the pitch line itself stands out prominently. The profile is completely destroyed and for all practical purposes the gear is not fit for service.

**Cause:** This failure is usually caused by inadequate lubrication or by excessive operating temperature, surface load, or surface speed, all of which generate excessive heat. When the lubricant breaks down, the welding and tearing destroys the profile in minutes.

**Destructive Scoring:** Heavy scoring has taken place above and below the pitch line, leaving the material at the pitch line. As a result, the pitch line pits away as it attempts to redistribute the load. Usually the gear cannot correct itself and ultimately fails.

**Remedy:** The lubricant must be able to stand up under the load, speed, and temperature con-

ditions of the mesh. Extreme-pressure additives are useful. Also, special high-viscosity compounded gear oil will often prevent scoring of this nature. Synthetic fluids with anti-scoring additives will prevent scoring at higher temperature.

In general, a careful analysis of the amount of heat being generated by the mesh is necessary, so that a fluid can be chosen that matches these conditions. If this is not possible, the gear set must be redesigned to reduce surface stresses, mesh losses, pitch-line velocity, and inlet-oil temperature.

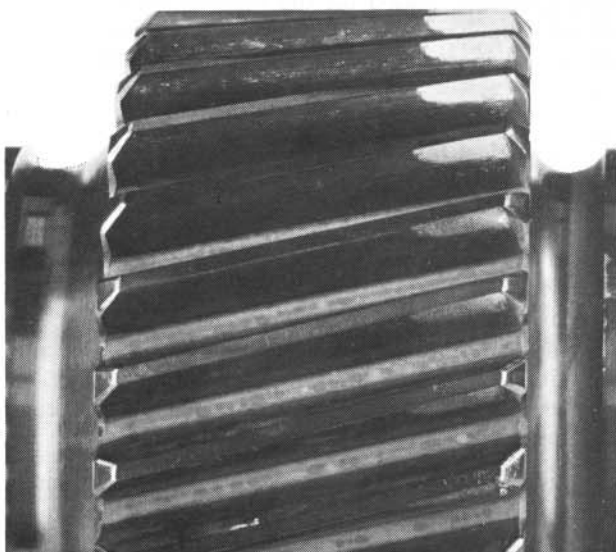
This scoring, similar to moderate scoring, takes place in localized areas along the contacting pattern of the gear teeth. Scoring is usually concentrated in these areas and does not spread across the full face width of the contacting gears.

**Localized Scoring:** This high-speed, high-load helical gear shows localized scoring on the ends of the teeth. This failure was caused by a design oversight: when the gear casing reached operating temperature, differential expansion caused a shift in alignment across the face of the gear. The resulting load distribution caused scoring.

**Cause:** Scoring of this nature is usually the result of local load concentrations caused either by design or by unintentional factors such as a misalignment resulting from poor manufacture, deflections under load, or temperature gradients across the face due to non-uniform cooling of the mesh. If the load concentration is near the ends of the teeth, the cause is misalignment, with more load being carried on this portion of the teeth than the lubrication film can support. Sometimes load is concentrated in the center of the gear teeth.

A crown is sometimes used at the center of the tooth to prevent the load from shifting if the design is prone to misalignment under operation. Because of this crown, the center of the tooth carries more load; often the higher load breaks down the lubrication film, permitting metal-to-metal contact and subsequent scoring. Sometimes an "effective crown" can be caused by unequal cooling of the mesh, which in effect causes the diameter of the gear in the center to grow with respect to the diameter of the two ends. Wide-face gears are particularly prone to this difficulty.

**Remedy:** Scoring failures of this nature can be avoided by eliminating localized loading. If misalignment is present, the gear casing may be deflecting non-uniformly, gear-shaft deflection may be excessive, bores of the casing may be out of parallel, or the gears themselves may be cut with a helix-angle error.

To eliminate localized scoring due to temperature gradients, particular attention must be paid to obtaining uniform heat removal across the mesh. Changes may be necessary in the amount of cooling oil and how it is applied to the mesh. If scor-

ing is the result of too much crown, this crown can be reduced to a safer level.

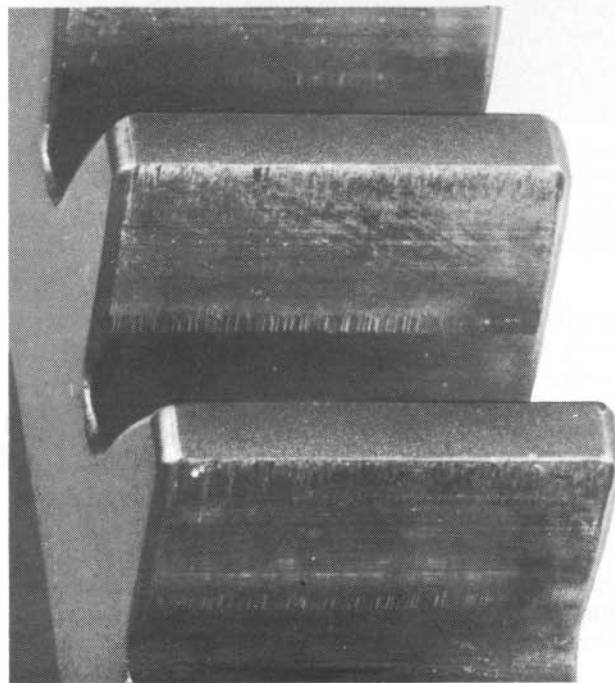
**Tip and Root Interference:** This gear shows clear evidence that the tip of its mating gear is fouling the root section. Localized scoring has taken place, causing rapid metal removal in the root section. Generally, interference of this nature can cause considerable damage.

In this type of scoring, the deep-dedendum portion of the gear shows definite signs of metal removal and may often show destructive radial scratch marks. Other portions of the contacting face look undamaged. Sometimes the tip of the gear or pinion shows unmistakable signs of metal removal, with the damaged tips having an abraded look and tear marks in the direction of rotation.

**Causes:** This condition is not entirely dependent

on the normal causes of scoring failure. The tip of the pinion may require tip modification, the root section of the gear may have a profile error, or the gear pair may be running on tight centers. The heavy loading at the tip or root of the mating pair or the interference caused by a tight mesh prematurely breaks down the lubricant film, causing rapid metal removal at the tips and roots and general abrasion of the teeth.

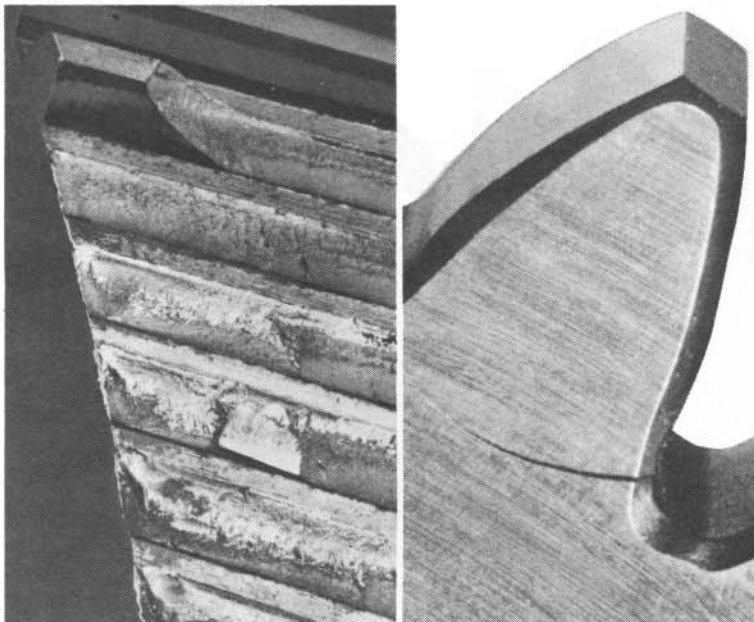
Gear-tooth failure from bending fatigue generally results from a crack originating in the root section of the gear tooth. The whole tooth, or a part of the tooth, breaks away. Most often there is evidence of a fatigue "eye" or focal point of the break. The break shows signs of fretting and conventional smooth beach marks in the break area. Generally there is a small area that shows a rough, jagged appearance, indicating this was the last portion of the tooth to break away.

**Beam Bending Fatigue:** (right) This aircraft power spur gear shows a fatigue crack caused by stresses at the root fillet.

**Beam Bending Fatigue:** (left) Each failed tooth started at a crack that had been in progress for some time. All the failed teeth show evidence of fretting corrosion and typical beach marks common to this kind of failure. Undoubtedly one tooth broke away first, causing an impact that then quickly broke the remainder of the teeth.

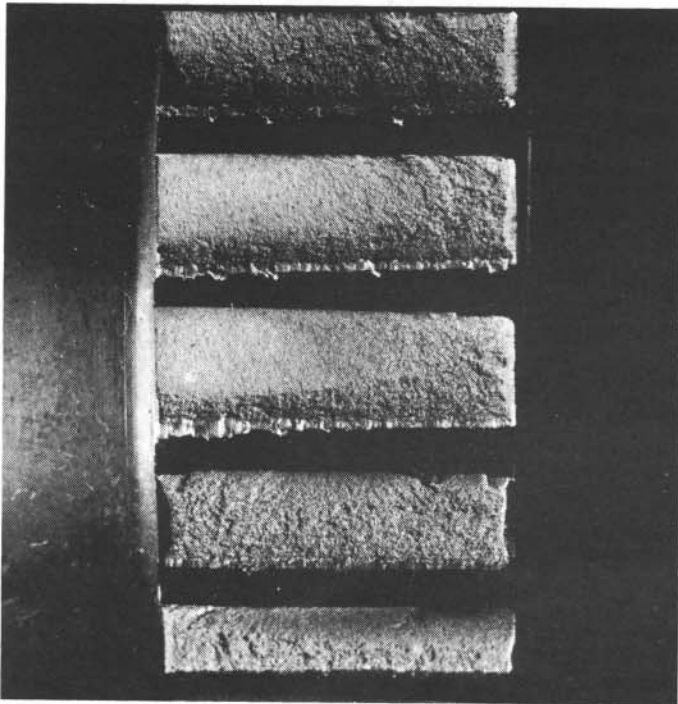
**Overload Breakage:** The break in this hardened and ground spur gear has a brittle fibrous appearance and the complete absence of any of the common beach marks associated with fatigue failure. In this case, one tooth failed from shock and the force was transmitted to successive teeth. As a result, several teeth were stripped from the rotating pinion.

**Remedy:** It is difficult to design against failures of this type, since often the failure is a direct result of some unpredictable occurrence. It may

be possible to incorporate overload-protection devices, such as torque-limiting couplings with shear sections.

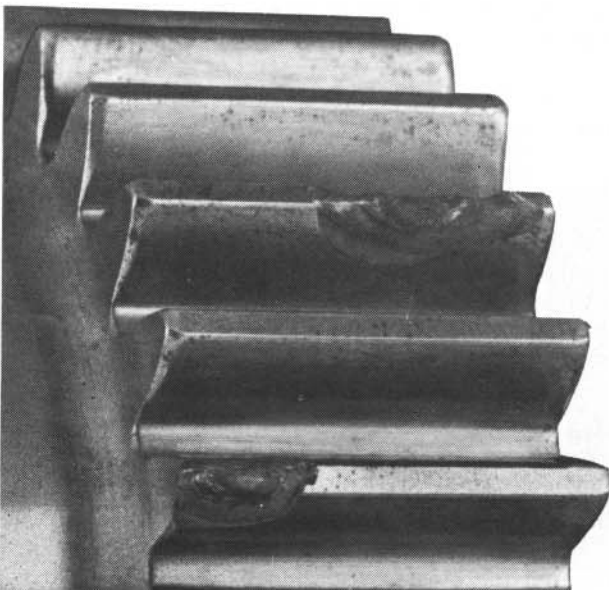
Gear-tooth breakage is usually associated with the root-fillet section of the gear tooth; however,

**Random Fatigue Breaks:** These breaks are not typical beam bending failures. They originate high on the tooth flank and are somewhat uniformly dispersed across the face of the gear. Failures of this nature originate from stress risers other than at the root fillet. In this installation, fatigue failure resulted from grinding cracks on the tooth flanks.

breakage failure can occur in other portions of the gear tooth. Sometimes, the top of a gear tooth will break away or large chips will fatigue away from the end of a tooth.

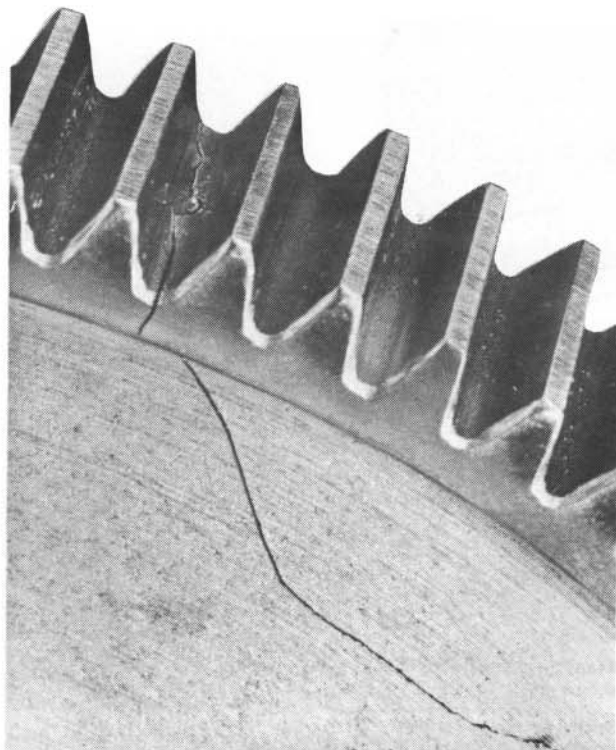
The rim of a gear usually fails between two adjacent teeth. Cracks propagate through the rim and into the web. Sometimes, cracks appear in the web near the rim and web junction without disturbing the rim itself.

**Rim and Web Failure:** This hardened and ground spur gear fractured through the root section. The crack propagated from the root section into the web of the gear. Such failures are not uncommon on highly loaded thin rims and webs.

**Cause:** Often, the failures are caused by flexure stresses in the gear teeth. If the crack starts from a high stress point, it may propagate through the rim instead of across the tooth at the root section. Web cracks may be caused by stress risers from holes in the web, or by web vibrations.

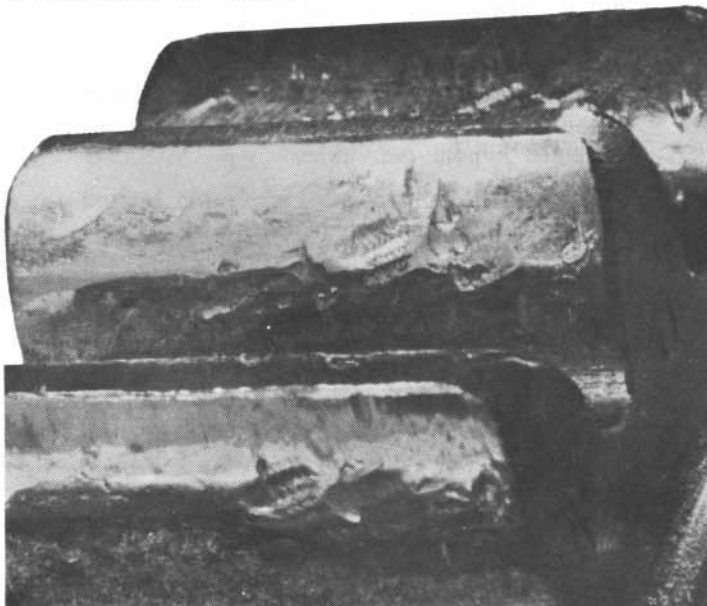
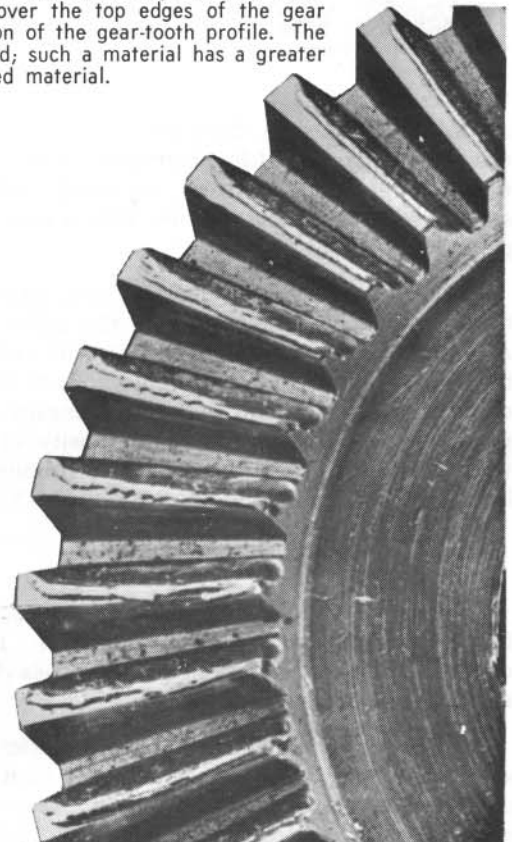
**Cold Flow:** This medium-hard spur gear shows signs of bad surface deformation due to rolling and peening action. This gear was operated long after the initial surface distress occurred, resulting in a battered cold-worked surface.

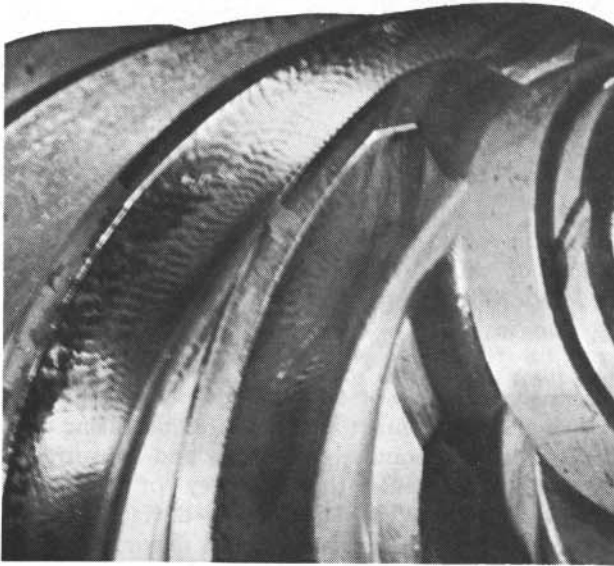
This is a periodic wave-like formation at right angles to the direction of sliding or motion. It has a fish-scale appearance and is usually observed on hardened gear surfaces, although it can occur on softer tooth surfaces under certain conditions. Rippling is not always considered a surface failure, unless it has progressed to an advanced stage.

**Cause:** High contact stresses under cyclic operation tend to roll and knead the surface causing the immediate subsurface material to flow. Low-speed operation is usually associated with this type

**Rippling:** A typical case of rippling appears on this hardened hypoid pinion. Note the waviness or fish-scale pattern. Rippling often shows up on highly loaded hypoid gears but can be produced on highly loaded spur gears as well.

of failure, because it does not build up adequate elasto-hydrodynamic film thickness. This combination of high contact stress, repeated cycles, and an inadequate lubricating film will produce a rippled surface.

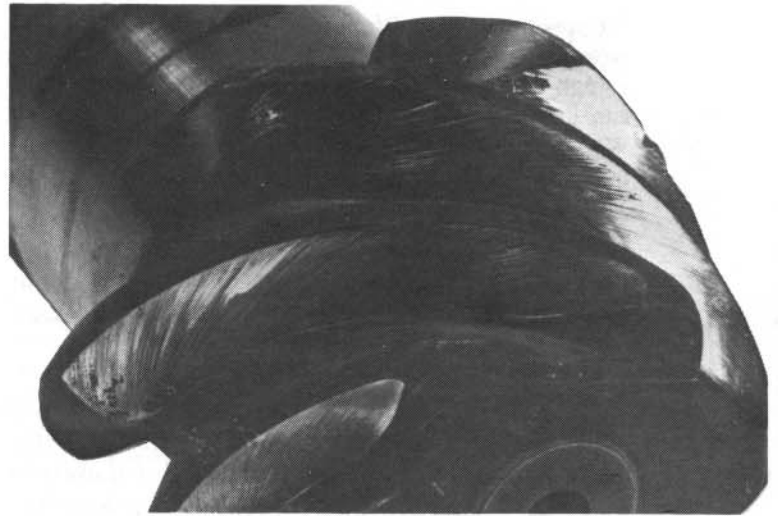
**Cause:** Ridging is caused by the plastic flow of surface and subsurface material due to high contact compressive stresses and high relative sliding velocities. It is often present on heavily loaded worm

**Ridging:** On this hardened pinion, note that some wear has taken place and that some surface pitting is present although the predominant mode of failure is ridging.

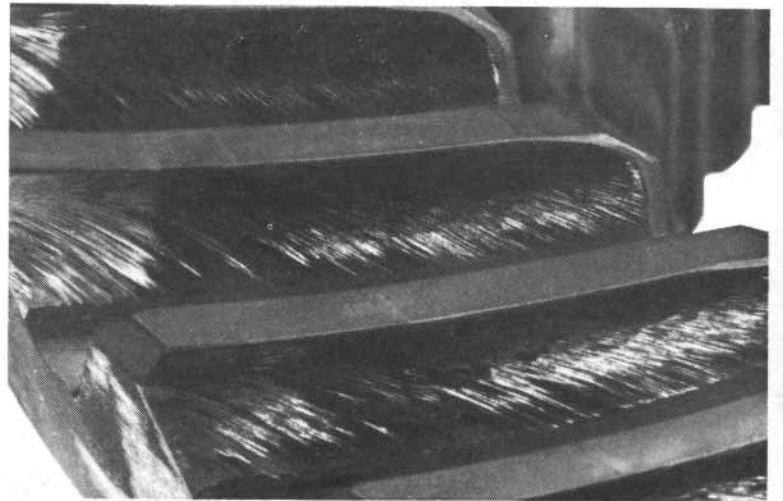
**Ridging:** This is an excellent example of how ridges form on the surface of a hardened gear. Although the surfaces are very hard, the ridges show a definite peak-to-valley effect in the direction of sliding.
