Xtek Service and Reconditioning Center

Caster Shear Gearbox Rebuild

Caster Shear Gearbox sent from steel mill to Xtek for evaluation and reconditioning as a result of a bearing failure.

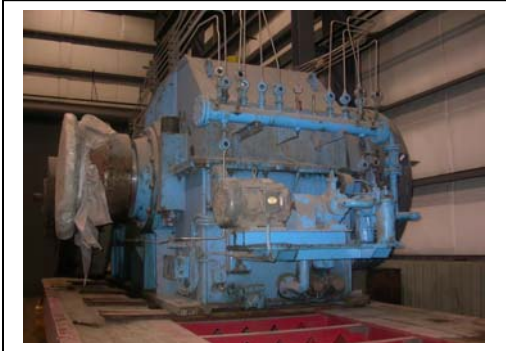
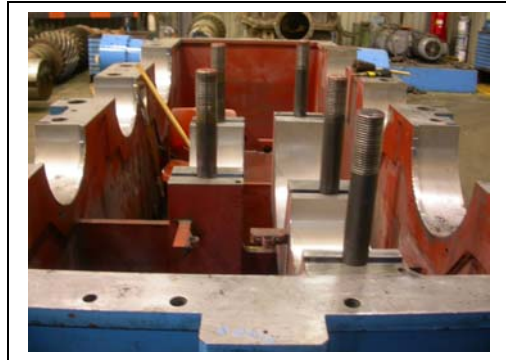
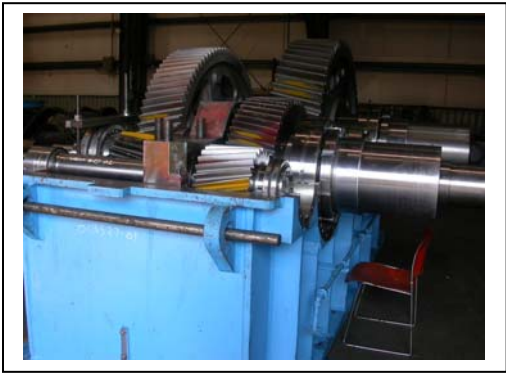
- Gear tooth contact patterns (yellow markings on gear teeth in photo above)
- Lubrication system check
- 24-hour no-load run test to monitor and record bearing temperatures and overall gearbox noise

- Regrinding all of the gears
- Weld repairing and re-machining the housing
- Rebuilding the brake and clutch
- Manufacturing a new flywheel
- Upgrading the lubrication system
